TECHNICAL BULLETIN

This bulletin refers to Ford Superduty trucks built 2017 and beyond (when a snowplow is operated a truck may experience following: radio shut down, instrument cluster backlighting inoperative, erratic climate control blower motor operation etc.)

QVM Bulletin: Q-280 Date: 07, December 2017

QVM Bulletin: Q-277 Date: 29 August 2017

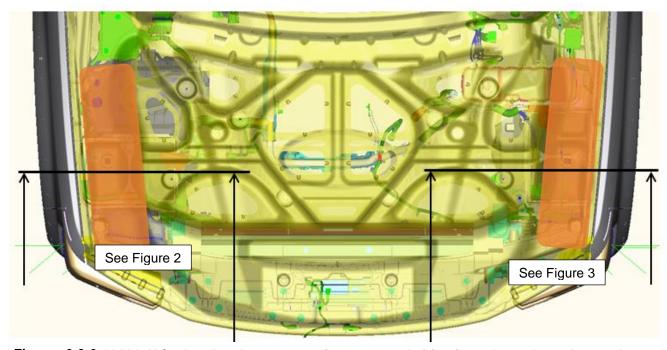
Ford has received a number of reports of upfitted chassis cab trucks that have experienced electrical grounding concerns, resulting in interior smoke, odor, and in some cases, fire. Ford recently investigated this concern with several upfitters and concluded the cause was aftermarket electrical equipment involving B+ power contacting the underside of the hood.

The reduced clearance to the underside of the hood for added electrical equipment on top of or near the primary or secondary battery may not be apparent when the hood is open. If any B+ equipment is mounted in the low clearance zone as indicated by the diagram, a minimum of 15mm must be confirmed between bottom of hood and any equipment (including any B+ shielding and under hood insulation) mounted in the engine compartment when hood is fully closed. Several methods exist to confirm equipment and shielding meets minimum clearance to bottom of hood (e.g. clay test, borescope).

Figure 1: 2017 Super Duty Under Hood Plan View. Low clearance to underside of hood in areas highlighted in orange

Do not mount or place electrical equipment, including but not limited to connection terminals, cables, relays, fuses, and fusible links on top of or near the primary or secondary battery in a location that has low clearance to the underside of the hood as indicated by orange rectangles in the figures that follow.

The upfitter must ensure that any electrical equipment or shielding mounted under hood does not come into contact with the hood or hood components.

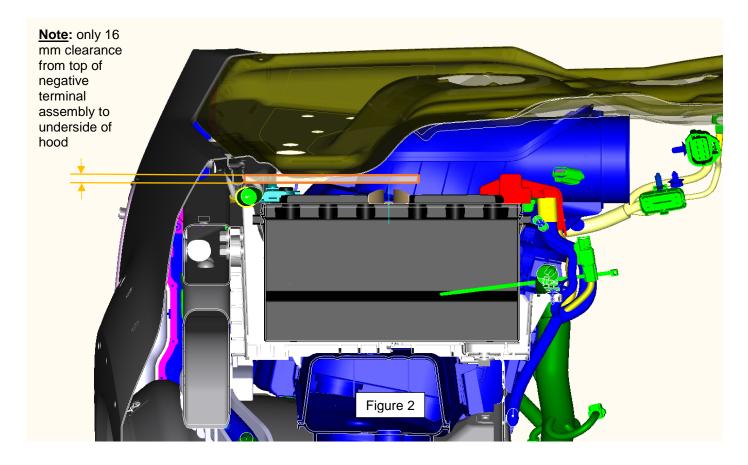
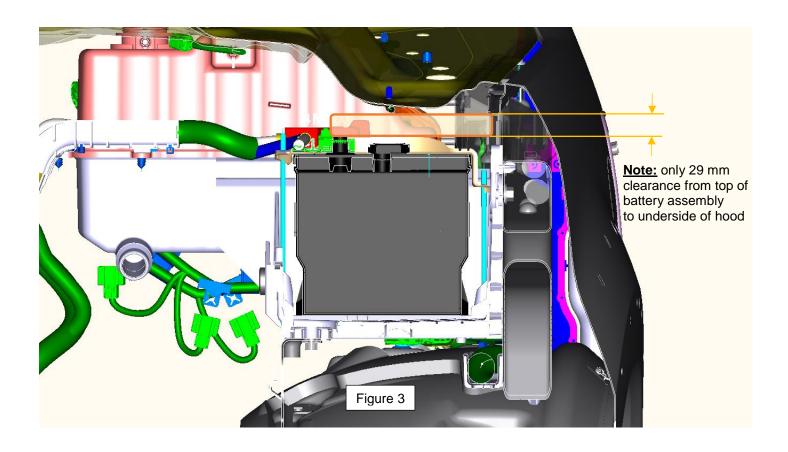
<u>Figures 2 & 3:</u> Vehicle X-Sections. low clearance areas (orange rectangles) for aftermarket equipment between battery & hood inner

Electrical equipment added to the engine compartment during any aftermarket installations / modifications must be positioned to prevent any B+ power from coming into contact with the underside of the hood when closed. All B+ related equipment must be placed / routed per recommendations within this bulletin, adequately retained, shielded / covered, and confirmed to have clearance to the hood when closed to prevent unintended battery short to ground and damage to vehicle wiring (e.g. radio antenna and radio harness within the instrument panel).

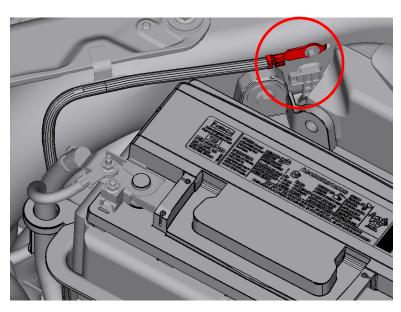
<u>Description:</u> The 2015MY F-150 battery charge state is determined with a Hall Effect sensor on the

negative battery lead. All negative current must pass through this sensor. Failure to do so will result in malfunction of the vehicle charging system and shortened battery life. **Do not**

<u>Procedure:</u> To ensure proper charging system function, the battery return should be made at the

grounding point shown and circled in red in the picture below:

Addition grounding point specifications:

Eyelet ID: 7mm Bolt: M6

Torque: 9 +/- 1.4 Nm
